**RESEARCH AND DEVELOPMENT TESTING
OF YTTRIA/RARE EARTH
STABILIZED ZIRCONIA MATRIX BRICKS
IN THE PILOT TEST UNIT (PTU) AT AEDC**

C. R. Tinsley

ARO, Inc.

November 1972

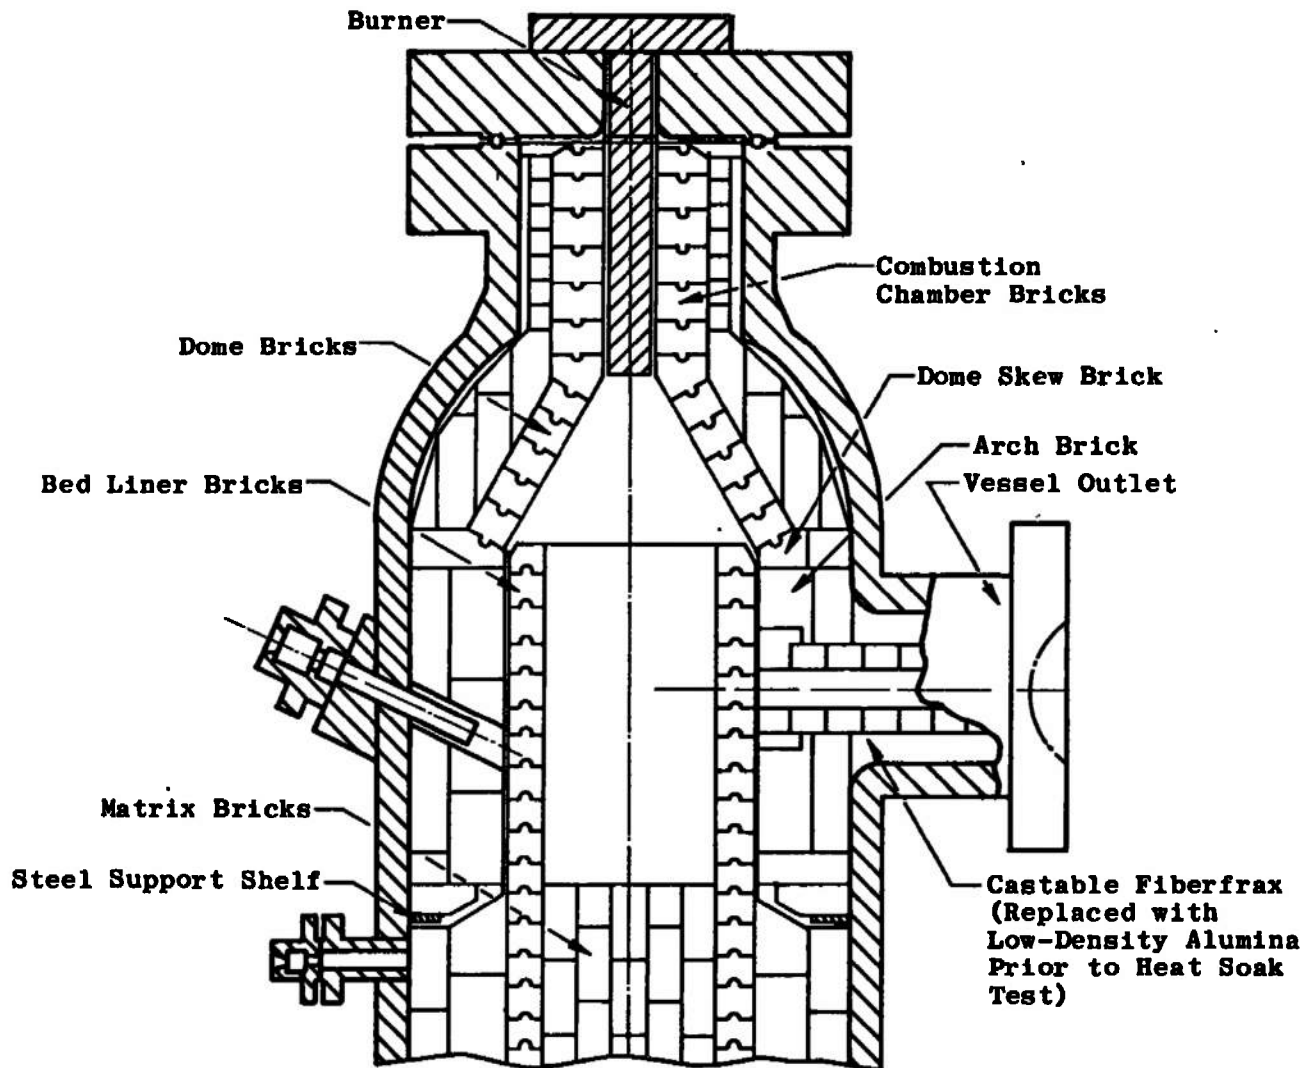
Fig. 8 Schematic of Heater Dome and Combustion Chamber Area

Visual inspection of the heater combustion chamber bricks and arch bricks adjacent to the dome skew bricks (see Fig. 8) revealed fracturing, spalling, and crumbling in these areas. However, replacement of the refractories was not deemed necessary.

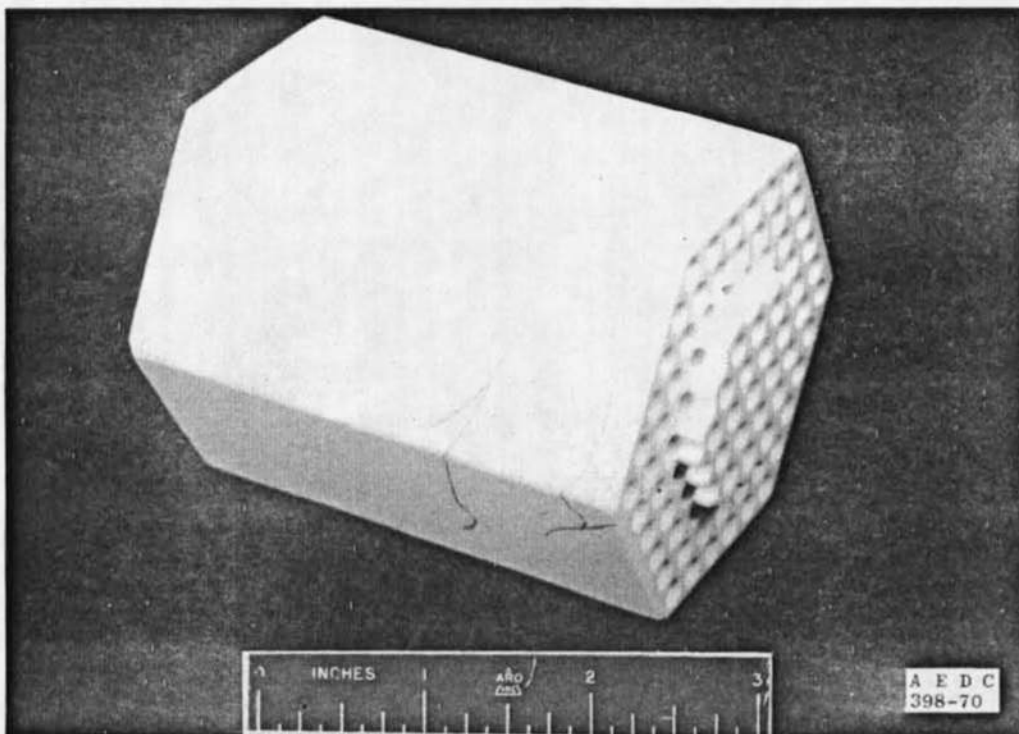
b. Column 8, 12.6 w/o, Coors

Inspections after run 37 revealed (1) that the sample matrix bricks installed before run 33 were in good condition with some hairline cracking and (2) that heater combustion chamber insulation refractories exhibited further degradation. Pertinent photographs taken during the inspection are presented in Figs. 12 and 13.

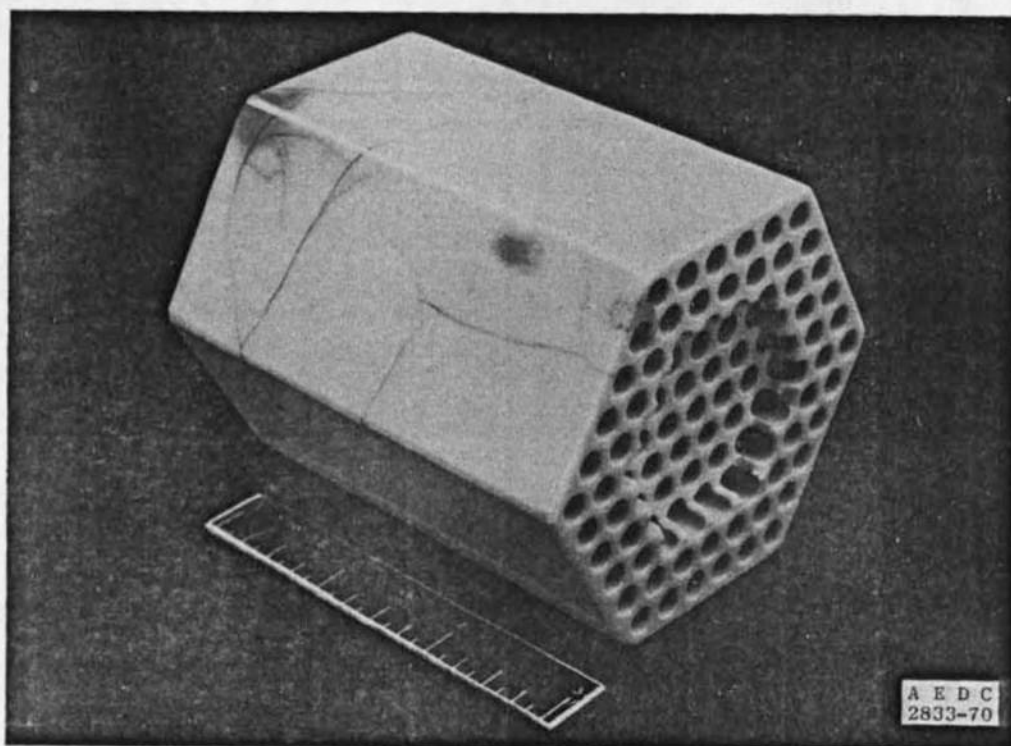
b. Column 8, 12.6 w/o, Coors

Posttest 38 inspections revealed (1) that nitric acid erosion was the prime factor causing burner deterioration and (2) that selected matrix bricks inspected were in good condition with only a few additional hairline cracks. Pertinent photographs taken during the inspections are presented in Fig. 15. The bricks depicted in Figs. 15a and b were also photographed after run. 37 (see Fig. 12) so that the effects of testing could be documented in typical matrix bricks.

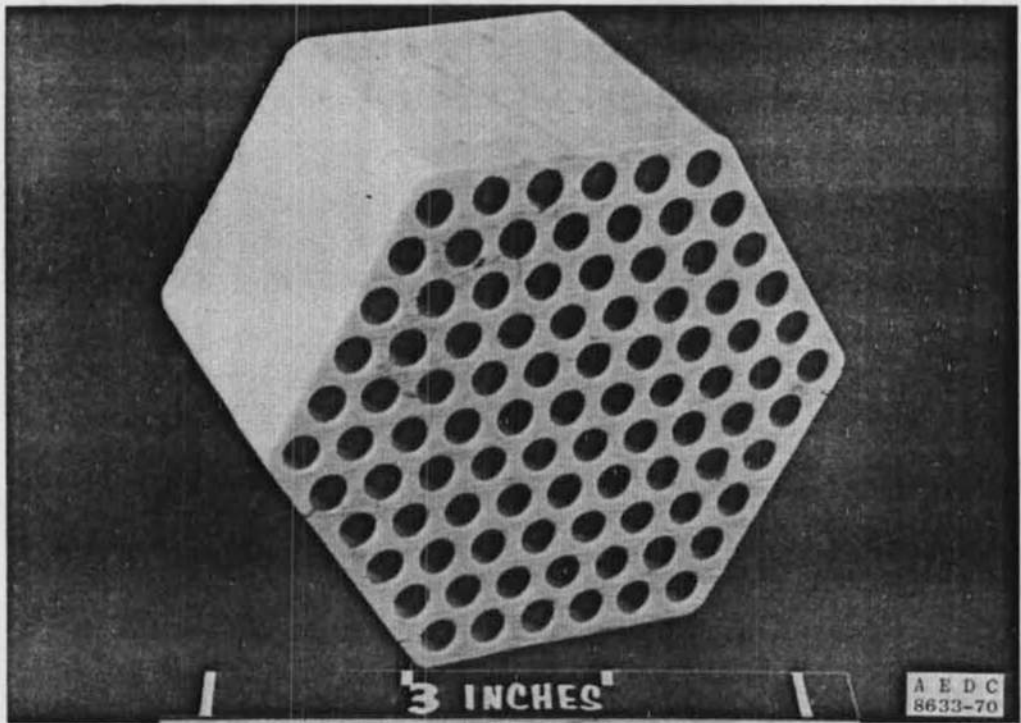
c. Coors, 13.8 w/o, Location 19-5

The second major inspection of the matrix refractories was conducted after run 69. Inspections revealed that a water leak had developed at the burner tube tip exterior; therefore, a complete examination was made of all sample matrix bricks placed into the heater before run 45. All high density sample bricks were found to contain hairline cracks. Coors high-density sample bricks in one column beneath the burner were all fractured into small pieces as a result of the water leak. All sample bricks remained stabilized throughout the test series. However, in general, the high density bricks appeared to be more susceptible to vertical fracture with increasing yttria content.

Presented in Fig. 19 are photographs typical of the various high density bricks removed from the heater for inspection. It may be noted that practically all cracks are in the vertical (longitudinal) direction.

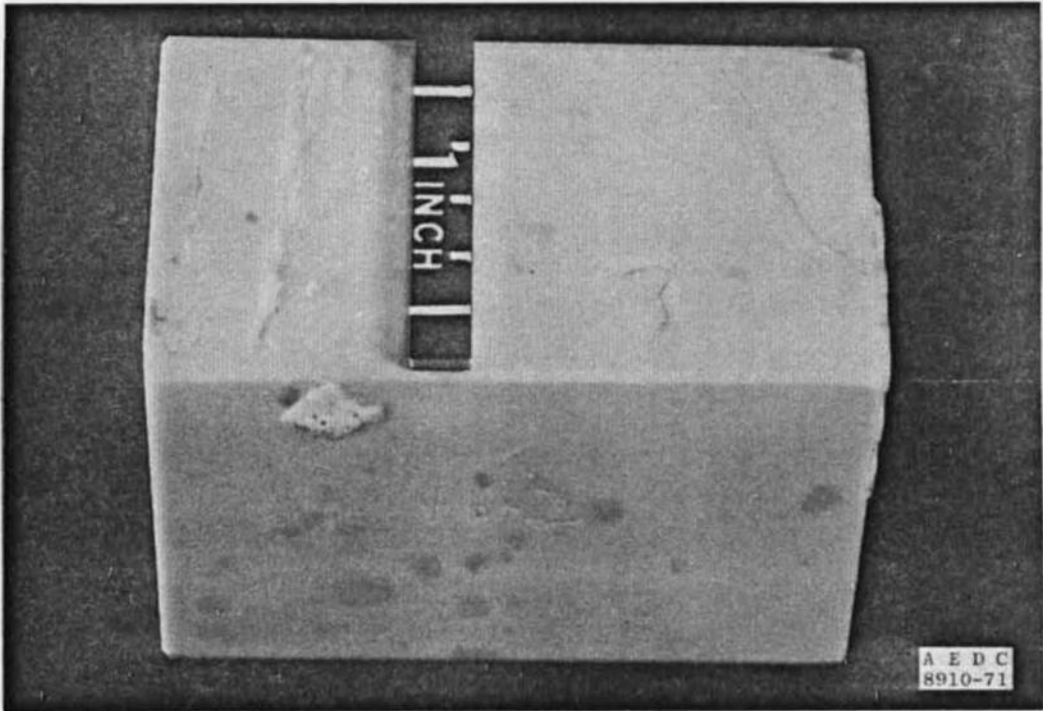
a. Side "A"

Fig. 29 Matrix Brick Exhibiting Stress Marks, Post-Run 44
